University of Florida Conservation Area Land Management Plan
Bartram-Carr Woods

Introduction

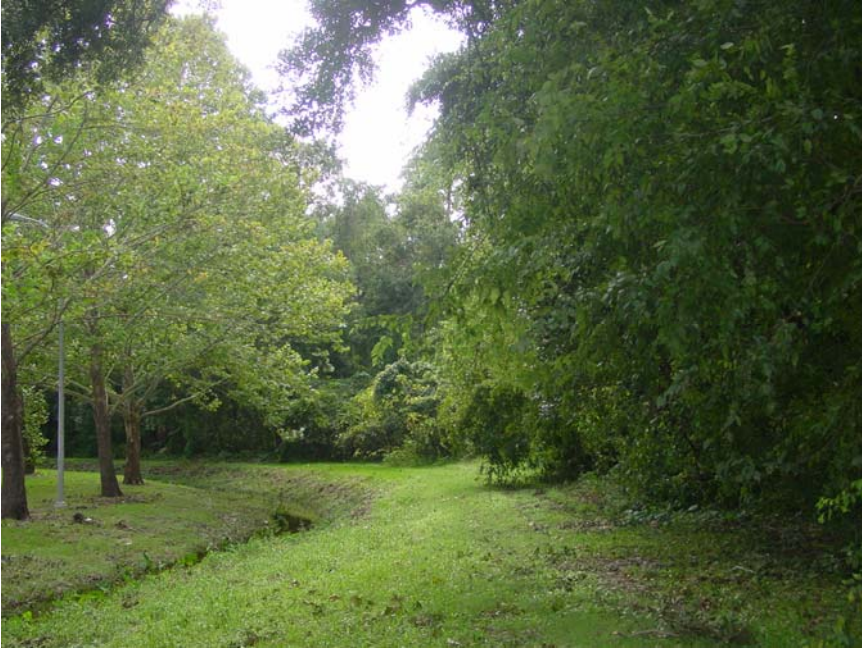
Unnamed Creek at Base of Bartram-Carr Woods

Upstream of this Conservation Area, both creeks show heavy side bank erosion and down cutting due to the lack of upstream stormwater treatment and the high amount of impervious surface. Due to safety concerns, these creeks will need to have some instream counter measures like riprap added to prevent further erosion. After convergence, the creek (the creek was at one time called Cal's Canal, named after the person who oversaw its channelization) becomes fairly flat and begins to show the results of upstream erosion in the form of sedimentation buildup. In fact, the creek in this area acts effectively as a sediment trap in that water velocity slows down and allows for particulate matter to settle out. However, this sedimentation buildup creates a need for regular dredging so that the floodplain does not rise and culverts do not get filled in.

These woods contribute relatively small amounts of run-off to the main creek. Unlike impervious surfaces, water is taken up and slowed down by vegetation and recharge to the surficial aquifer. According to mapping completed by Casseaux and Ellington Inc., wetland and floodplain portions of this Conservation Area buffer the creek's path, with wetlands extending just slightly past the creek's normal flow path and floodplains extending further up bank to a maximum of 300 feet from the creek's edge. In a few areas stormwater outfalls empty into the woods, functioning like intermittent streams that only flow to the creek during large storm events. The base of these stormwater outlets (where the erosion is greatest) should be studied as potential locations for rain gardens or other treatment BMPs to treat and reduce velocities of stormwater emptying into the woods. An issue observed by the working group that inventoried this area was the unnecessary mowing along the north side of the creek.

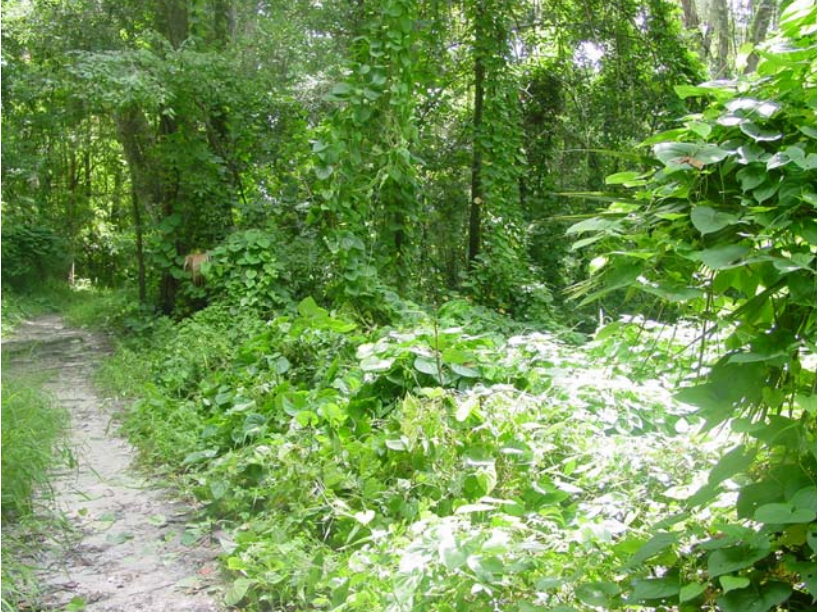
Bartram-Carr Woods – Air Potato vine taking over understory.

a managed natural area that also lends itself to use as a teaching resource for class observation. Thus, the understory of this Conservation Area, which is being taken over by air-potato vine, needs to be thinned creating a more inviting park like setting. One major improvement that has been recommended is the need to formalize trails. Trails within the wooded areas should be designated and mulched, with unnecessary ones blocked off with plantings, boulders or tree felling. On the south-side of the creek completion of a mostly existing paved bicycle/pedestrian path is proposed that is part of a campus and community-wide network of greenways. While on the north side of the creek proposals include a naturalistic pedestrian trail, mulched instead of paved, that follows the creek (east-west) and also connects into a north-south trail. Additionally, the north-south trail, which runs the entire length of the woods, is envisioned as having a bridge crossing over the creek that would connect into the bicycle/pedestrian greenway. Other improvements recommended for this Conservation Area include habitat enhancements like bird and bat boxes and wildlife friendly plantings, along with specimen tree plantings. Additionally, fencing, plantings, or a line of boulders should be placed along the edge of the creek buffer, in order to stop unnecessary mowing, and along Newell Drive to keep out unauthorized parking.
